Innovative IGT Repair Solutions to Enhance Power Plant Profitability

By Kevin Davis, President, Frarendi, Inc.

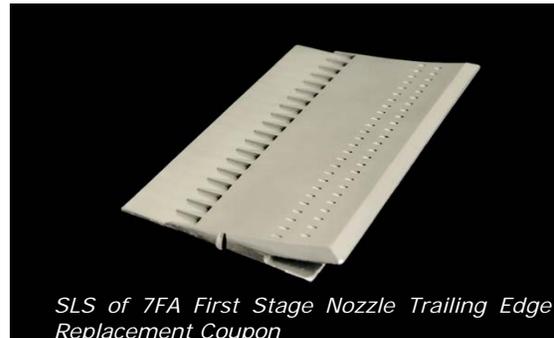
SLS of 7FA First Stage Nozzle Trailing Edge Replacement Coupon

First stage nozzle trailing edge replacement coupons are strategically designed and manufactured to be an exact dimensional and metallurgical match to OEM first stage nozzles. Using a new or refurbished OEM part, the surfaces of the nozzle rails, platforms and airfoils are laser or optically scanned and the data is imported into an industry standard CAD/CAM software package. Because nozzle airfoils are hollow to allow air to cool the part during operation, Computer Tomography (CT) scans, X-rays or cut-ups of the original part are used to determine the wall thickness and internal geometry features. Surface features, such as cooling air exit holes, are also measured. With this information, Stereolithography (SLA) or Selective Laser Sintering (SLS) is used to generate the prototype (Figure 1) to serve as a visual tool and as a way to initiate casting.

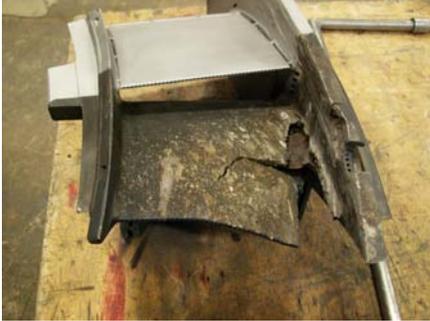
With the coupon ready to be installed, the damaged nozzle segment is prepped for repair. Figure 2 shows a trailing edge replacement coupon being readied for welding on a GE Frame 6 nozzle. When coupons are manufactured with precision EDM cooling hole geometry, the repair process is significantly simplified and much more effective.
