# POWEREngineering

## Repairing Hot Section Nozzles Can Be Cost-Effective

*An effective method for repairing hot section nozzle trailing edges is coming for large gas turbines.*

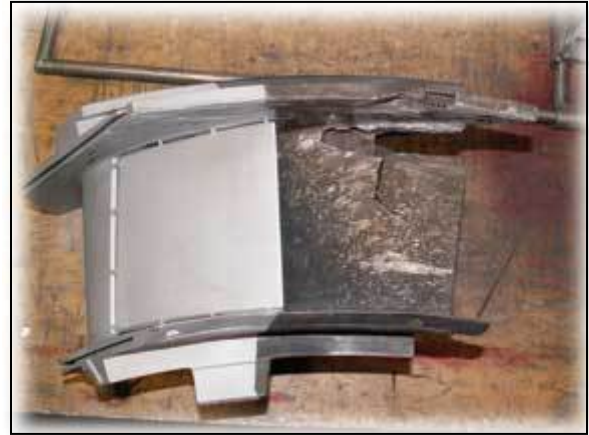
Even severely damaged nozzle blades can be cut out and a trailing edge coupon dropped into place ready for welding.  
Photo courtesy of Frarendi.

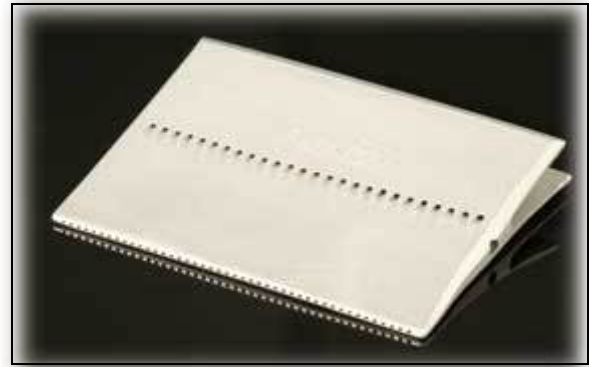
7EA nozzle segment and the 7FA SLA trailing edge coupon pix being taken this week.

The new coupon recently moved from the plastic "stereolithography" form to the casting stage and will be available this summer. The company is also planning a fix for the Siemens-Westinghouse 501D5, a model of gas turbines that began service in 1982 and is currently deployed worldwide. A fix is also in development for GE's 9FA fleet. The company has streamlined its production process and can deliver on customer requests in as little as 12 to 16 weeks, says Davis.
